UPGRADING PGR-5330 FLASH MEMORY

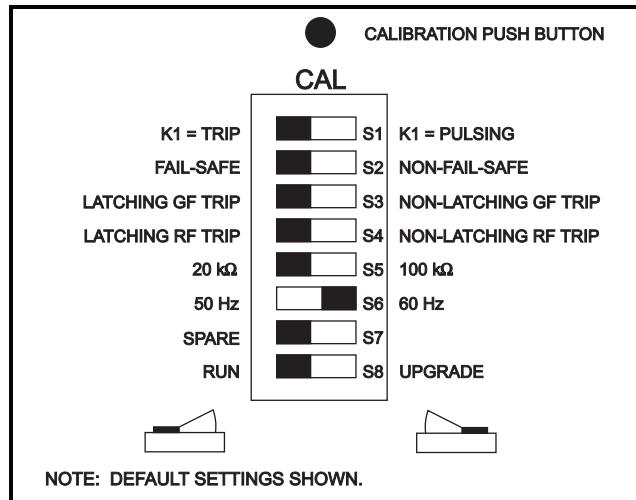
FIGURE 1. Configuration Switches.

- a) Run PGW-FLSH.
- b) Select the PGR-5330 from the list.
- c) Select the correct firmware file.
- d) Select the COM port you intend to use.
- e) If you are satisfied with the summary and your choices, select "Begin".
- f) The message "Please set unit to UPGRADE mode now" will appear.
- g) Remove supply voltage to PGR-5330.
- h) Set switch S8 (behind access cover on the PGR-5330 front panel) to UPGRADE. See Fig. 1.
- i) Apply supply voltage. The DIAGNOSTIC LED will be on and all relays will be de-energized.
- j) Press "OK" to start the upgrade. Wait until complete.
- k) Remove supply voltage.
- l) Set switch S8 to RUN.
- m) Apply supply voltage.
